Hydraulic Modeling of 90-percent Conceptual Design of the Willamette Falls Riverwalk Project

PREPARED FOR: Alex Gilbertson/Metro
Brian Vaughn/Metro

PREPARED BY: Ryan Mitchell/CH2M
Tim Bedford/CH2M

DATE: December 6, 2017

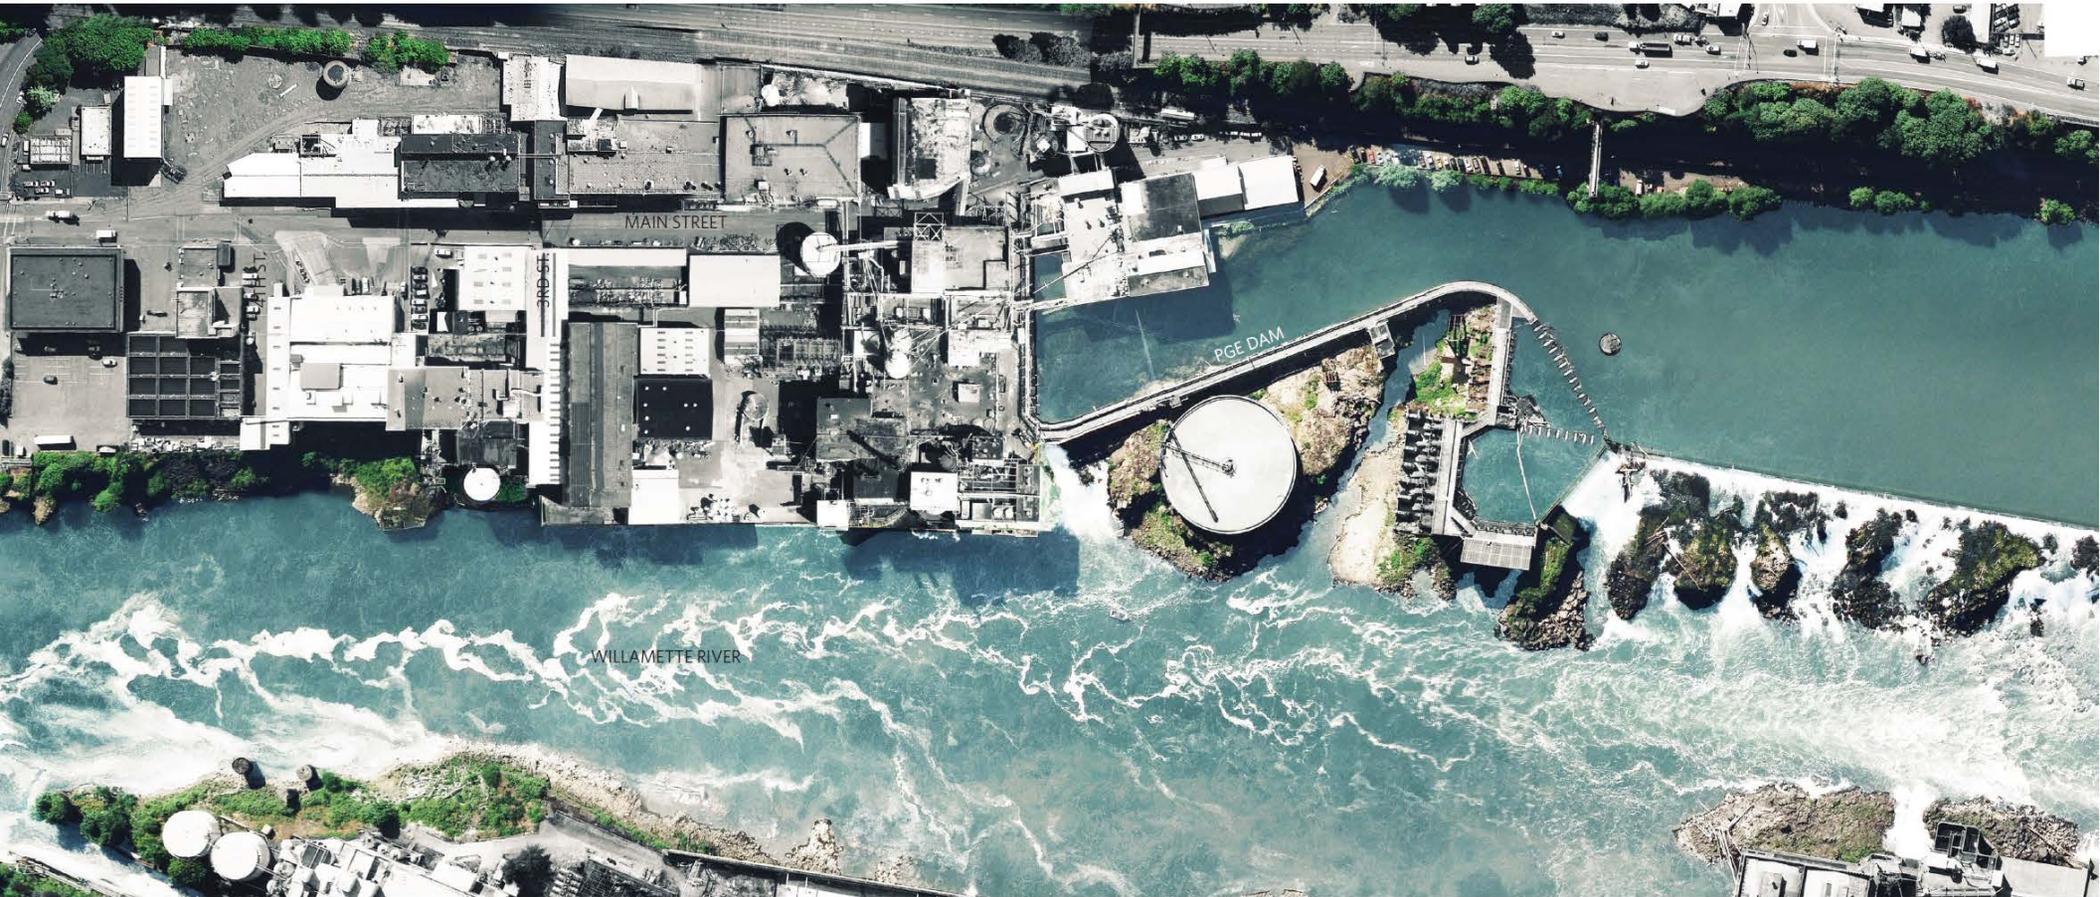
Source: Adapted from 90% Concept Design Package (Snohetta, May 5, 2017)

Willamette Falls
LEGACY PROJECT

Riverwalk - Concept Phase
90% Concept Design - May 5, 2017

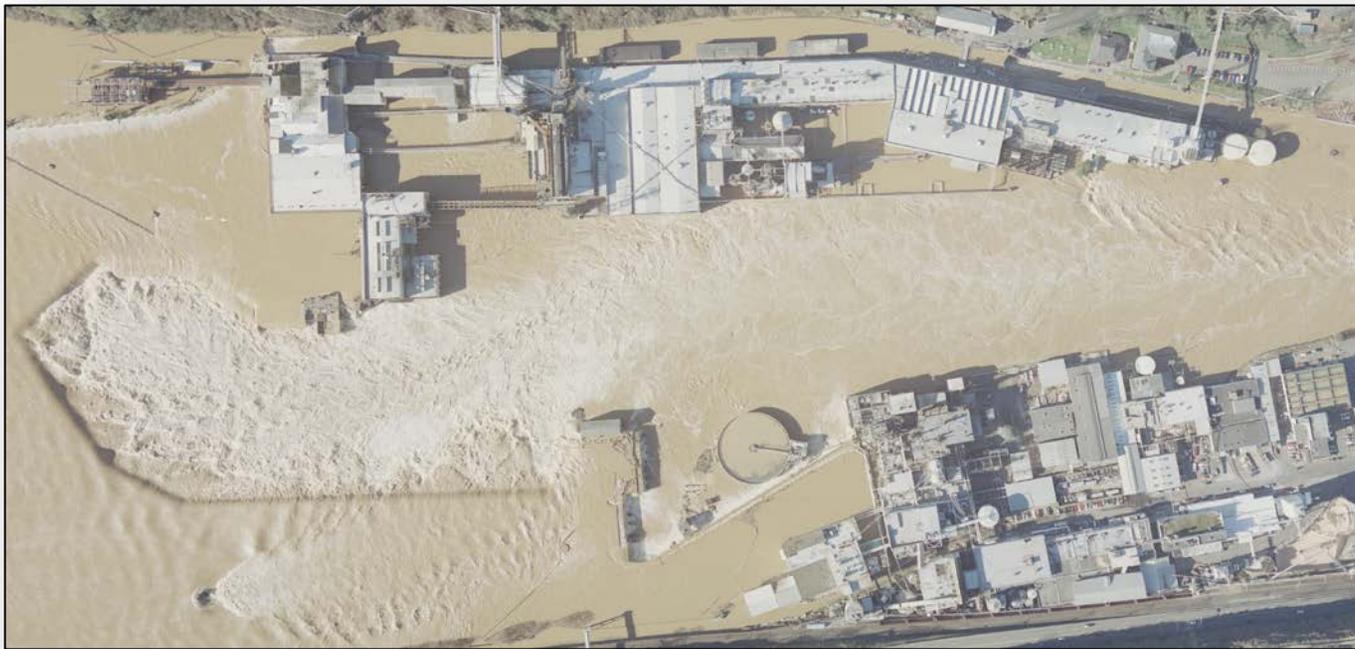
FIGURE 6
Introduction to Hydraulic Results
for the 1996 Flood
Riverwalk Project, Willamette Falls Legacy Site

- Evaluate hydraulic conditions during extreme floods such as the 1996 flood.
- Assess impacts to infrastructure and key design elements.

Flow Rate = 384,000 cfs (estimated)

Tailwater Elevation = 46.5 ft, NAVD 88

The discussion below summarizes the model results for this event which are shown in Figures 6 through 10 in Attachment A. It should be noted that the modeling effort of the 90-percent concept design did not attempt to characterize or simulate debris buildup, or various PGE spillway configurations during a large flood (such as February 1996). These impedances to flow on the dam crest can greatly affect the flow paths, water surface elevations and potentially the extent of inundation at the project site (for example, overbank flow around Mill E and down Main Street such as occurred during the 1996 flood).

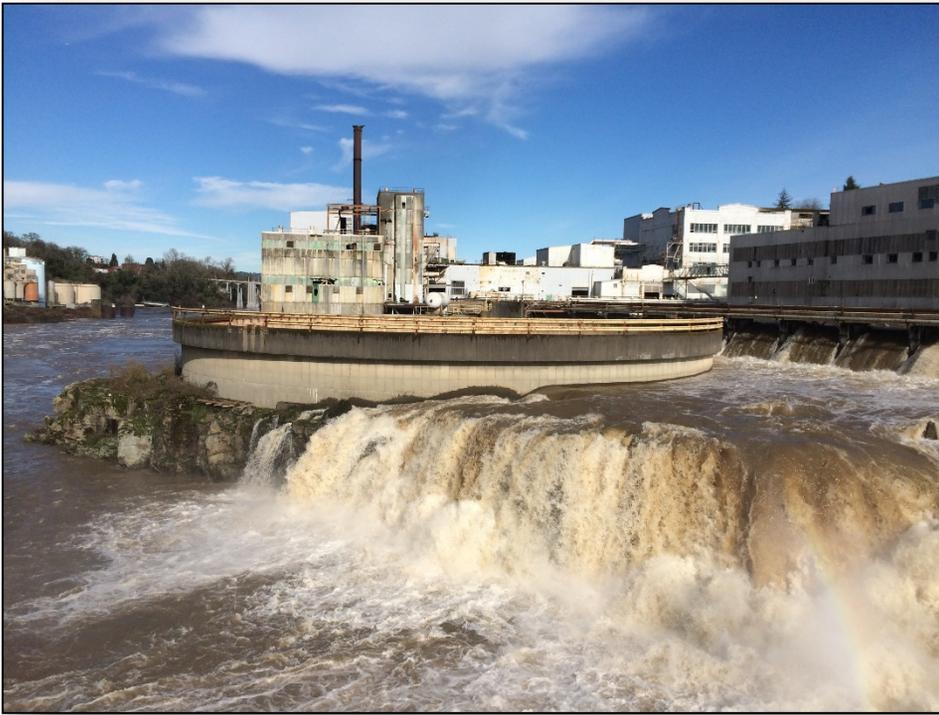
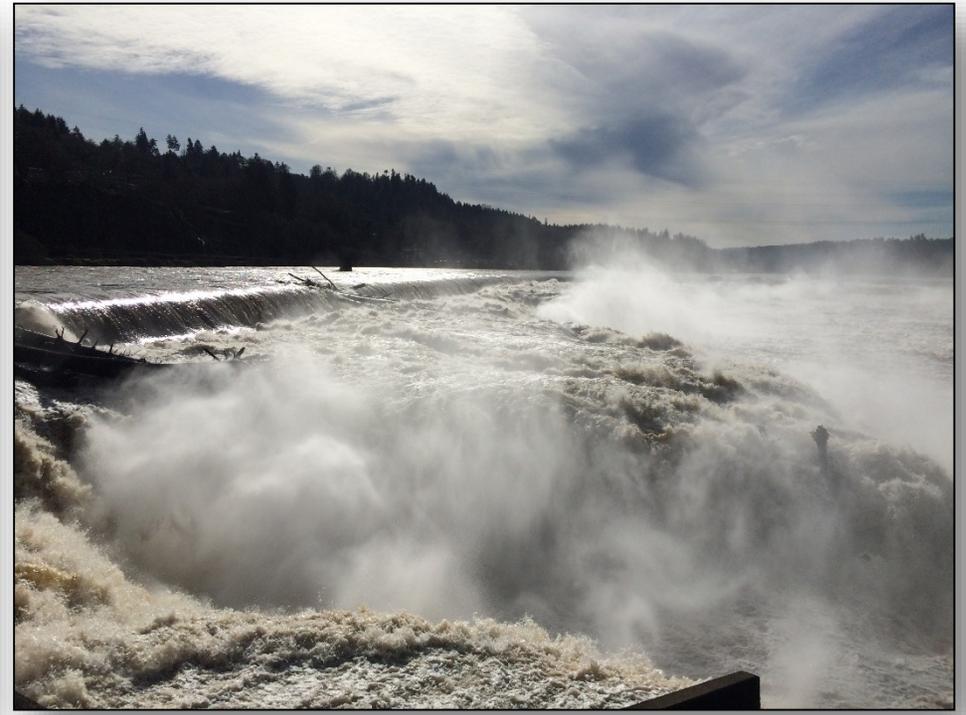
Field Photos of February 2017 Flood (Source: Metro)

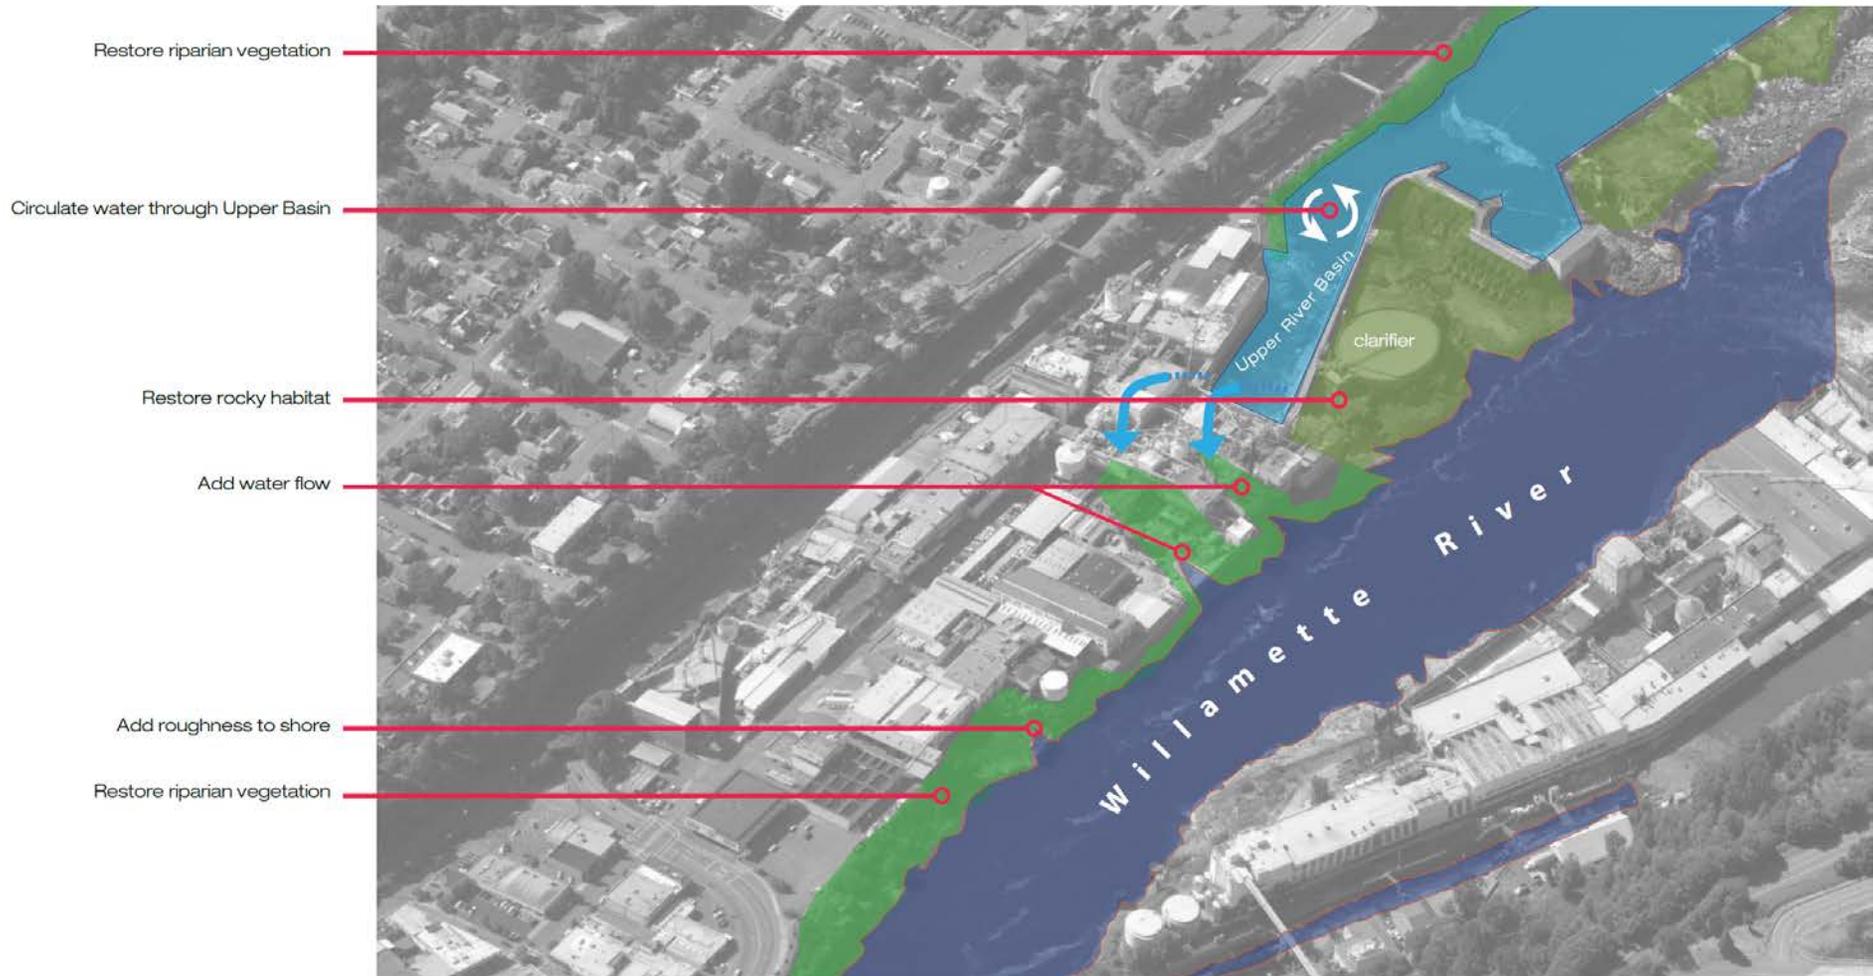
FIGURE 20
Introduction to Hydraulic Results for the Habitat
Flows (1 of 2)
Riverwalk Project, Willamette Falls Legacy Site

Habitat Opportunities:

Source: Graphic adapted from Willamette Falls Vision Document (2014, pg. 48)

The majority of spring runoff flow conditions are characterized between these two flows; the 90% exceedance flow (in other words, exceeded 90% of the time), equal to 11,700 cfs and 10% exceedance flow (exceeded 10% of the time), equal to 53,300 cfs. Habitat suitability and shallow water habitat areas are likely to vary between these conditions as river flows taper off entering into summer months. The discussion below summarizes the model results for these two events which are shown in Figures 20 through 24 in Attachment A.

Two design flows were selected to characterize the typical high and low flow conditions during this season.
